FastLUBE in the Media

New Compound Overcomes Stainless Bolt and Nut Thread Galling

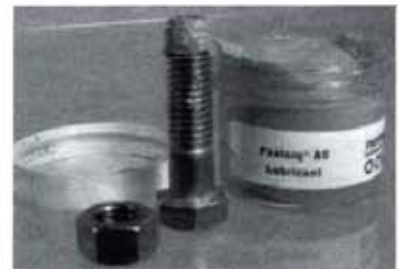
Anti-galling compound placed on bolt's end threads.

The compound was rubbed on the last three to five threads of the bolt's point end and the nut was started on the bolt. As would be expected, as soon as the nut encountered the bolt's thread nicks the torque required to rotate the nut immediately increased. What was not expected was that the nut could be screwed the full length of the bolt thread without the threads seizing together as a result of galling.

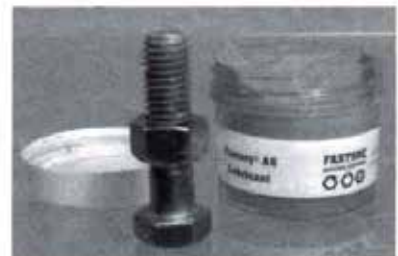
Nut goes entire length of bolt thread without seizing.

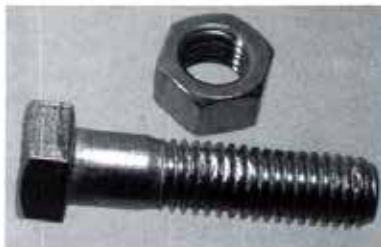
Stainless steel bolt with intentionally damaged threads.

The threads of a 1/2-13 302 stainless steel bolt were severely damaged by striking them repeatedly with a hammer. It was reasonable to assume that a 302

stainless steel nut would not go on this bolt without completely seizing on the bolt's thread due to thread galling.
