# New Compound Overcomes Stainless Bolt and Nut Thread Galling

by Joe Greenslade

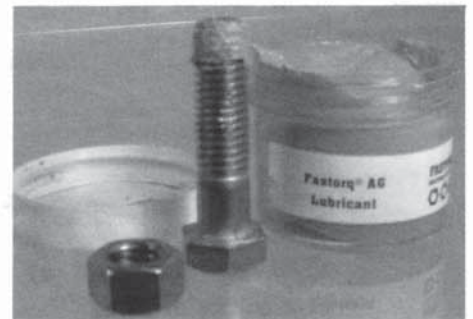
Anti-galling compound placed on bolt's end threads.

The compound was rubbed on the last three to five threads of the bolt's point end and the nut was started on the bolt. As would be expected, as soon as the nut encountered the bolt's thread nicks the torque required to rotate the nut immediately increased. What was not expected was that the nut could be screwed the full length of the bolt thread without the threads seizing together as a result of galling.

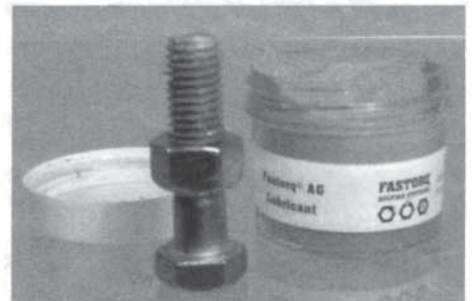
Nut goes entire length of bolt thread without seizing.

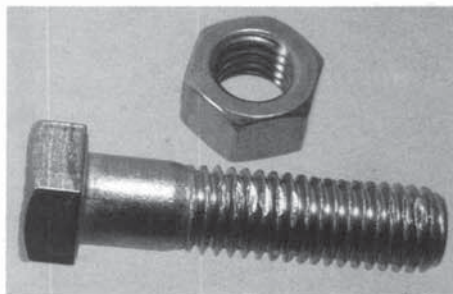
Stainless steel bolt with intentionally damaged threads.

The threads of a 1/2-13 302 stainless steel bolt were severely damaged by striking them repeatedly with a hammer. It was reasonable to assume that a 302

stainless steel nut would not go on this bolt without completely seizing on the bolt's thread due to thread galling.
